TITLE The analysis of earthwork and slope deterioration from aerial photographs

by **B McKinnon and W Heath**

McKINNON B AND W HEATH. (1996) The analysis of earthwork and slope deterioration from aerial photographs. *Paper to be presented at the Second Caribbean Conference on Natural Hazards and Disasters, Jamaica, 9 - 12 October 1996.*

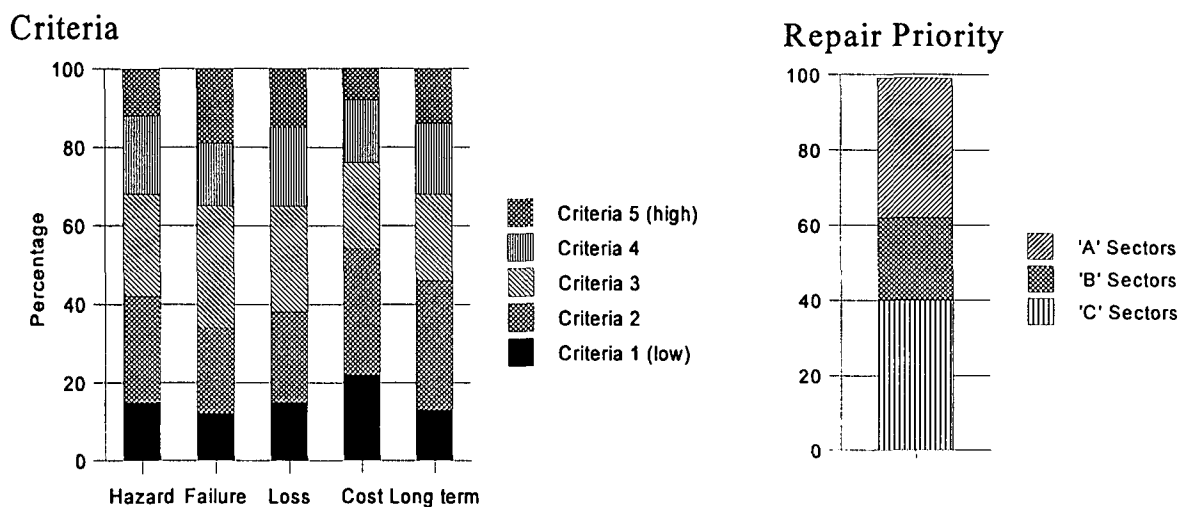
Figure 2. Chart showing the five risk criteria and repair priority.

The chart shows that almost 40% of sectors are graded 4 and 5 in the criteria, with the exception of 'repair cost'. For hazard risks to road users and failure risk there is a significantly high number of sectors, 12% and 20% graded as 5. This is reflected in the overall state of the road with 40% of earthwork sectors requiring immediate attention, repair priority 'A'. From this the road can be assumed to be in a very poor condition.

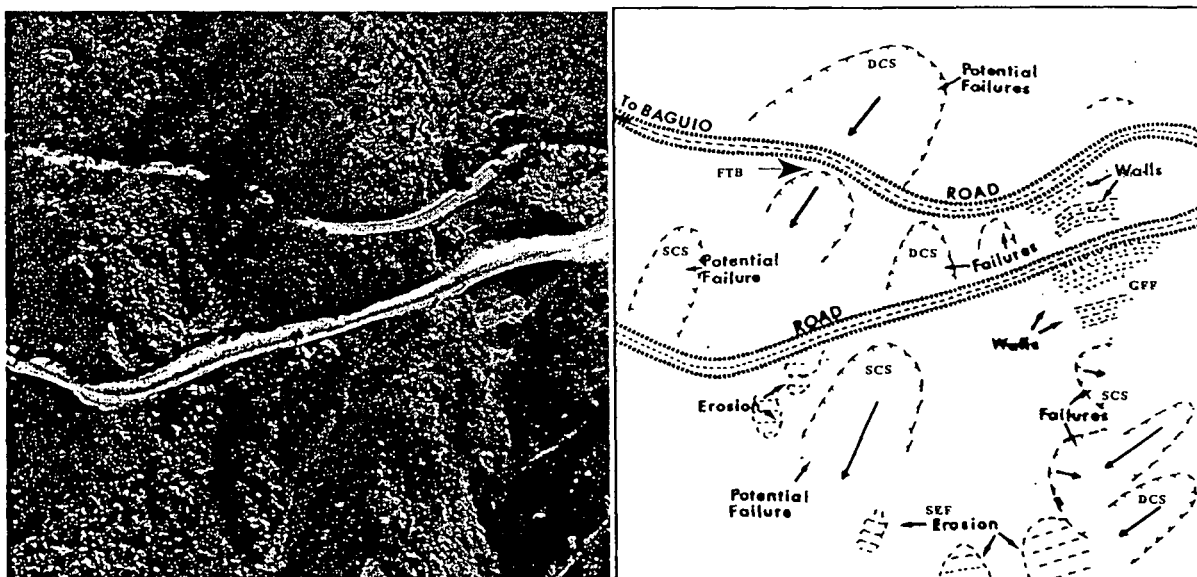
Figure 3. An aerial record of hairpin section with overlay showing details of problems.

The aerial photograph of a road sector shown in Figure 3 is reproduced to one third true size in black and white. It is a section of the Kennon highway in the Philippines at kilometre 238.2 from Manila and referenced as Sector 5.

Stage 3. The type of failure is recorded on the overlay for each earthwork problem as shown in Figure 3. The earthwork failures shown in Figure 3 include i) deep circular slides, ii) a failure through both slope and embankment, iii) shallow circular slides, iv) surface erosion failures, v) gully flow failure. The database diagrams, see section 3, Table 4 for a list of these, are shown in Figure 6. The next stage of analysis is to determine the cause of each type of failure and consider

ENGINEERING NOTES:-	
Sector Number :-	5
Earthwork Type:-	Hairpin Section.
Condition of Slope's :-	There are three zones where slides have moved through the two road levels. In two of the zones the road section has been re-aligned at some stage. In of the locations there are signs of further deterioration which must be arrested. The other notable aspect are the areas of erosion, which need to be controlled.
Condition of Embankment:-	Hairpin section, notes as those for slopes.
Action Suggested:-	The existing slope drainage system appears to be inadequate on the complex section. As a result the slopes are eroding and also becoming excessively saturated. Improved drainage is required to arrest the deterioration.
Size of Engineering Task :-	Large.
Long-term Stability :-	Generally poor, slope and embankment failures are likely unless extensive work is undertaken.

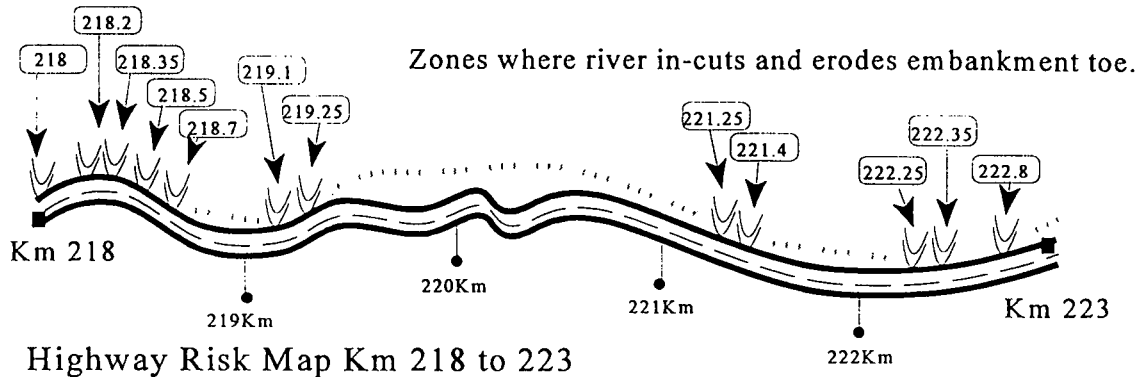
Figure 4. A risk map showing where the embankment is at risk.

A section of a risk-map showing places where the river cuts-in and is eroding the embankment between kilometres 218 and 223 is shown in Figure 4. These maps as produced from the

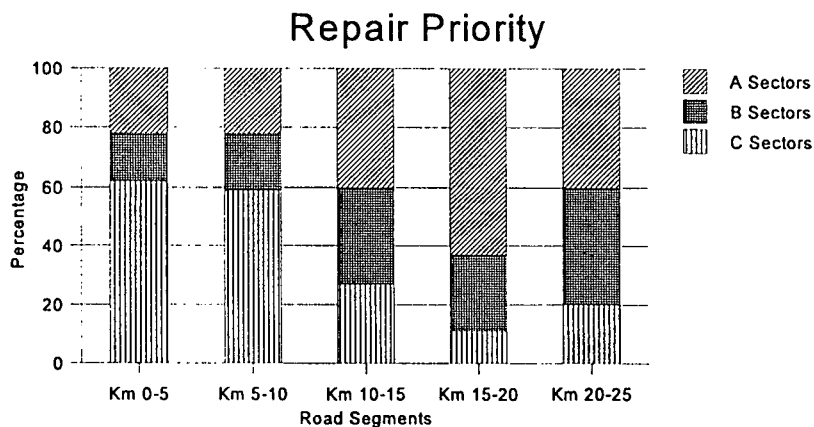
Figure 5. The distribution of serious earthwork problems over twenty-five Km of road.

As an example of the type of information the inventory can provide Figure 5 is a graph showing the number of earthwork sectors in each priority repair category, for each five kilometres of the road. Therefore not only the number of serious problems but their distribution on the road can be seen. In this instance it shows that serious earthwork problems show a definite increase towards kilometres 20 to 25. More than 100 similar graphs or tables containing information about a wide range of earthwork features are ready to use in the database.
