TITLE Highway slope problems in Indonesia

by **W Heath, B S Saroso and J W F Dowling**

Heath, W G, B S Saroso and J W F Dowling, 1990. Highway slope problems in Indonesia. In: REAAA. Proceedings of the 6th Conference of REAAA. Kuala Lumpur 4 - 10 march 1990.

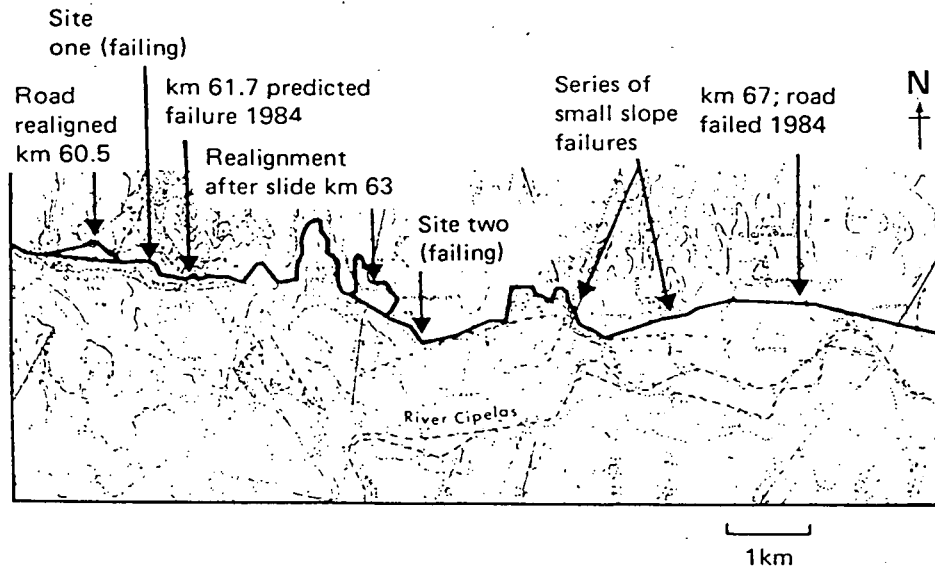
FIGURE 1. Slope failures on one section of Java's road network

11. As the present generation of roads tend to follow the natural topography the alignments are often steep presenting problems to traffic, on steep gradients, but avoiding the need for large cuttings and embankments. In terms of construction major problems occur after roads are widened. Also new roads attract urbanization and land-use and these factors create large scale changes to the characteristics of slope drainage and so affect stability. Areas of slope failure in Java encompass long sections of road ranging in length between 4 to 9 km. Within such zones there may be as many as twenty individual failure sites, see Figure 1 .

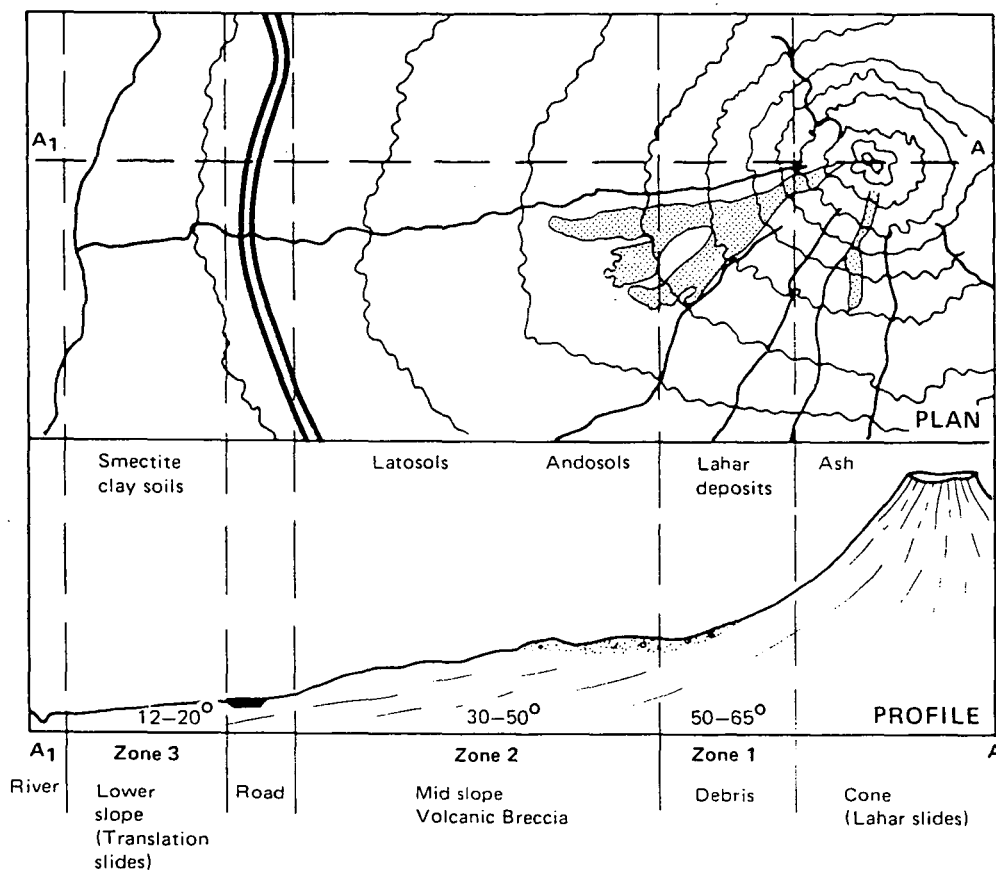
FIGURE 3. Plan and profile showing zones of instability.

20. In order to obtain more detail of the failing slopes large scale colour aerial photography was produced of four sites using a simple low cost technique, described by Heath (1980). An examination of this photography was significant in highlighting relic drainage features which contributed to failures occurring at Site 1., kilometre 64, and are described by Saroso, Dowling and Heath (1984). In this case gradual failure occurs on the lower slope where toe material is eroded by a river. This leads to slumps of the road adjacent to where groundwater is entering the weakest zones. Despite the use of many remedial techniques at this site, including concrete piles, retaining walls and lightweight fill, the main problems, involving the failure of the lower slopes and excess water directed onto the road, have not been tackled and consequently failure continues to occur.

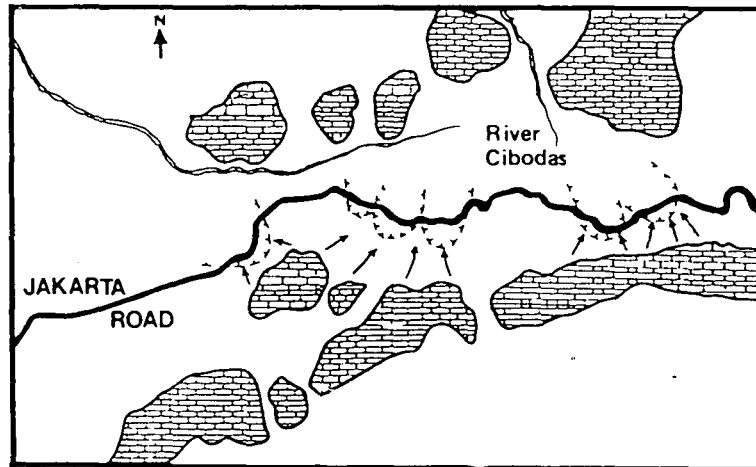
FIGURE 4. Groundwater concentration into failing sections of road.

21. At Site 3., on the edge of a massive upthrust block of limestone, slope problems are frequent. Maps of the alignment and an examination of aerial photographs indicated that the rainfall catchment and drainage features of the limestone both provide groundwater concentrations into these unstable sections of road, see Figure 4.

22. This type of problem was identified by Deer and Patton (1971) who suggested that the characteristics of colluvium, derived from hard rock sources, was to be coarse graded at the top, thereby allowing the free ingress of groundwater, and, being more weathered, finely graded towards the bottom where the hydraulic conductivity is consequently restricted. This type of permeability gradient would provide a rapid back-up of soil saturation in the slope during periods of heavy rainfall.

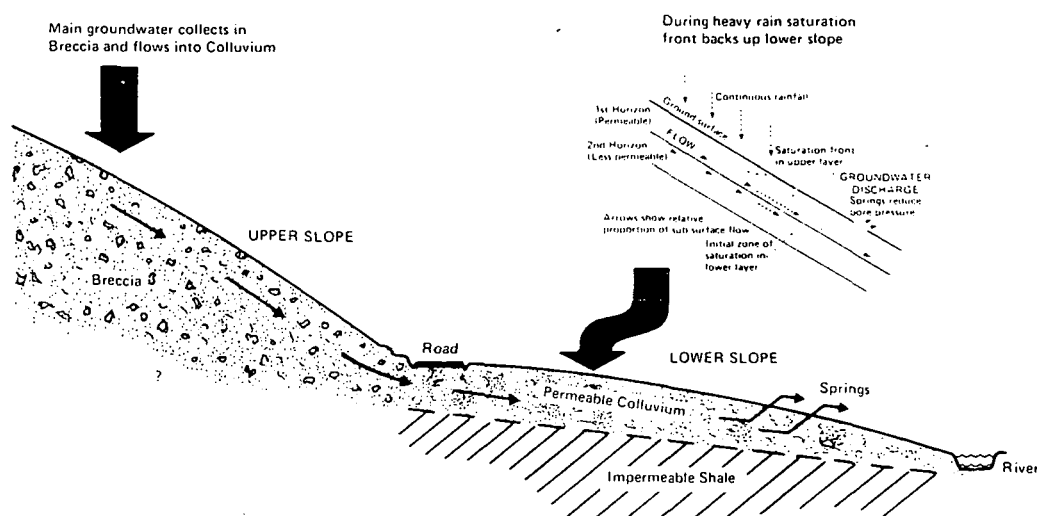
FIGURE 5. Conditions of groundwater on slopes in Java.

soil underlies a more permeable horizon the processes of groundwater flow have been frequently modelled and is described in most text books, Whipkey and Kirkby (1978). At a certain level of rainfall the upper soil horizon reaches the limits of its hydraulic conductivity and then a back-up of saturation occurs and continues up the slope, see Figure 5.

29. Such soil-water conditions occur on the majority of slopes investigated and the effects were measured, in terms of an increase in pore water pressure, at Site 1. during a two month period when the slope was failing.

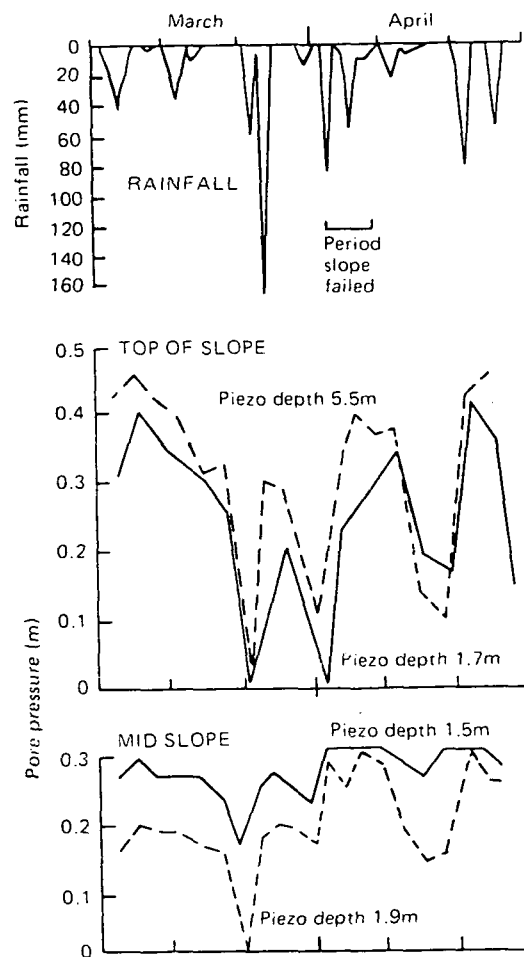
FIGURE 6. Rainfall and pore pressure data from Site 1.

31. Significant slope movement occurred at Site 1. in early April 1984 during a period of exceptionally heavy rain. The rainfall conditions and pore pressures for the period of slope failure are shown in Figure 6.

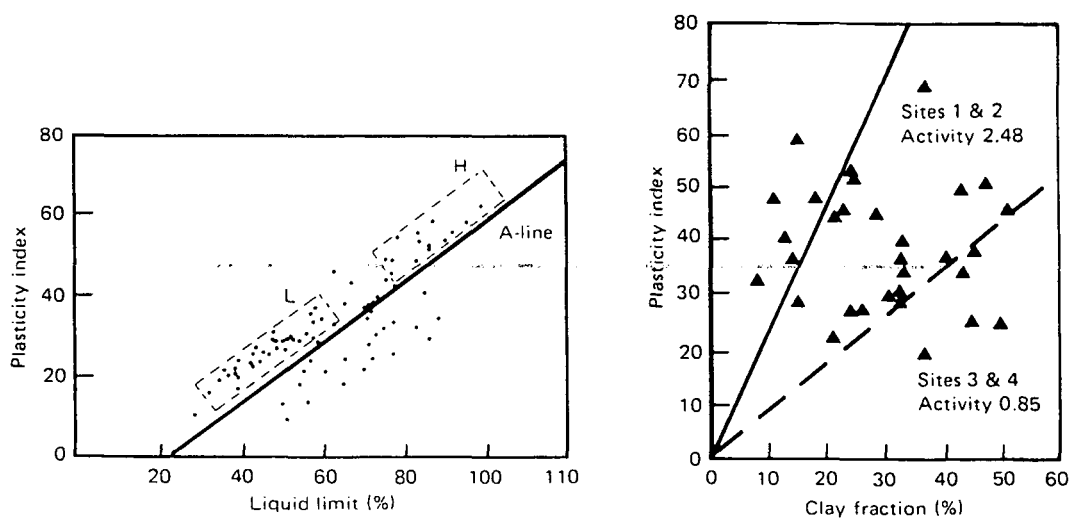
FIGURE 7. Plasticity and activity curves for clay samples.

44. The plasticity of almost all soils recovered was above the A-line on the liquid limit/plasticity curve and average activity values were 2.48 for montmorillonite and 0.85 for vermiculite samples. This is shown on the typical Liquid limit/Plasticity and Clay fraction/Plasticity curves for some representative samples of these soils, see Figure 7.

45. Many of the slopes, with angles of between 12 and 20 degrees, are therefore steeper than the soil characteristics suggest they should be. Using a limit equilibrium analysis based on the Janbu method of interslice forces, Janbu (1973) it can be shown that for the existing slope angles and depths of failure, for typical soil shear strengths, a Factor of Safety of 1.05 can be assumed for modest pore pressures and the water table at a depth of 1.5 metres. It is known from the rainfall data that much more severe groundwater conditions exist, than have been used in the analysis, for short periods each year. Therefore most slopes are inherently unstable, during such periods, and rapid creep failure occurs as a consequence.
