Cylinder retaining walls

C J Lawrance,* P G Carter** and N J Mapplebeck***

Abstract – Design options for landslide toe support walls are limited in Nepal, where funds and expertise for sophisticated structures are generally not available. The article describes the background to an experiment to build a semi-rigid gravity wall of novel design, that incorporates mainly local materials and the use of hand labour for its construction. The wall consists of freestanding, cylindrical columns of cement-stabilised gravel. Its advantages are that it is easy to build, it releases ground water efficiently and it is capable of accepting differential settlement. The wall has supported an unstable slope for four monsoons so far, without appreciable deterioration.

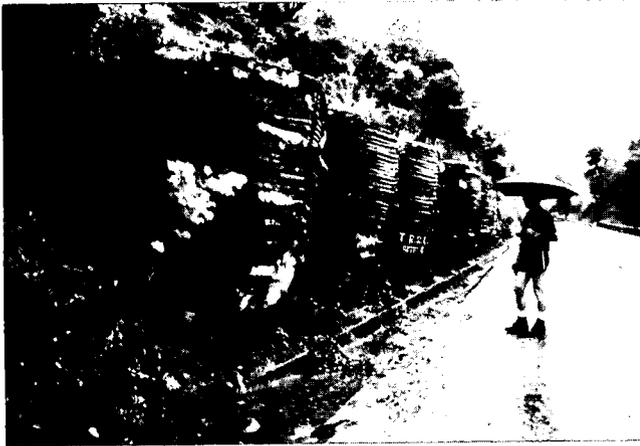
Fig 5 The first cylinder wall in the early stages of failure, four months into the first monsoon season. During the following few days progressive movement of the landslide led to the destruction of the wall along half its length

The wall withstood the landslide pressures for most of one monsoon season, but failed after a week of heavy rain during which 465mm fell (Fig 5). The wall failed by shearing of the fill. The skin was clearly not contributing to the shear strength of the cylinder, and once the skin had ruptured the fill poured out and the structure was destroyed within a few days by the slowly advancing debris mass. Despite this setback the design was felt to be intrinsically sound and potentially useful. The wall had resisted the forces of overturning and of basal sliding. It was also extremely freely-draining (between cylinders) and had been built efficiently by hand labour. It was decided that a full geotechnical analysis of the slope and the structure was justifiable, with a view to more accurately assessing the forces involved and producing a more balanced design.

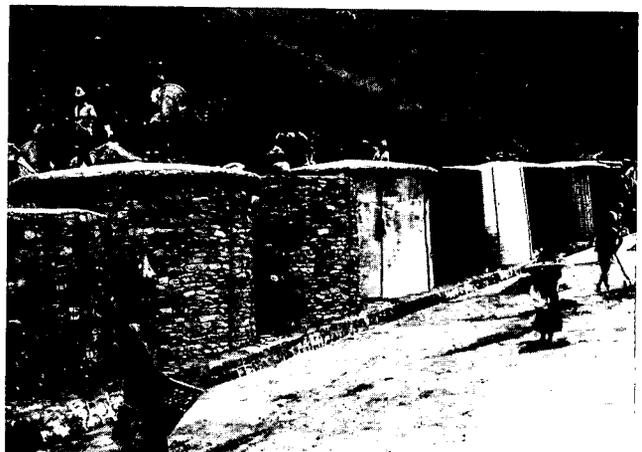
Fig 10 The replacement cylinder wall nearing completion. From left to right the skin types are: two of dry stone masonry, three of galvanised steel sheet (one bitumenised), two of bamboo palisade (one bitumenised), and two without a skin (temporary polythene skin removed after curing). Caps on cylinders are made of mortared stone with a tile eave

(see Fig 10) has yet to be settled. The skinless cylinder is the cheapest option but may in time suffer from degradation by surface weathering. The unprotected bamboo is already cracking and rotting. The sheet steel is expensive and may soon rust. The gabion-work skin is the most permanent and aesthetically the most pleasing. But it was the most expensive to build, and the length of time needed to put it up meant that horizontal construction joints had to be introduced into the fill, which could become planes of weakness under high earth pressures.
