**RRL Report LR 379**

**An investigation of cracking  
in soil-cement bases for roads**

**H. E. Bofinger and G. A. Sullivan**

**1971**

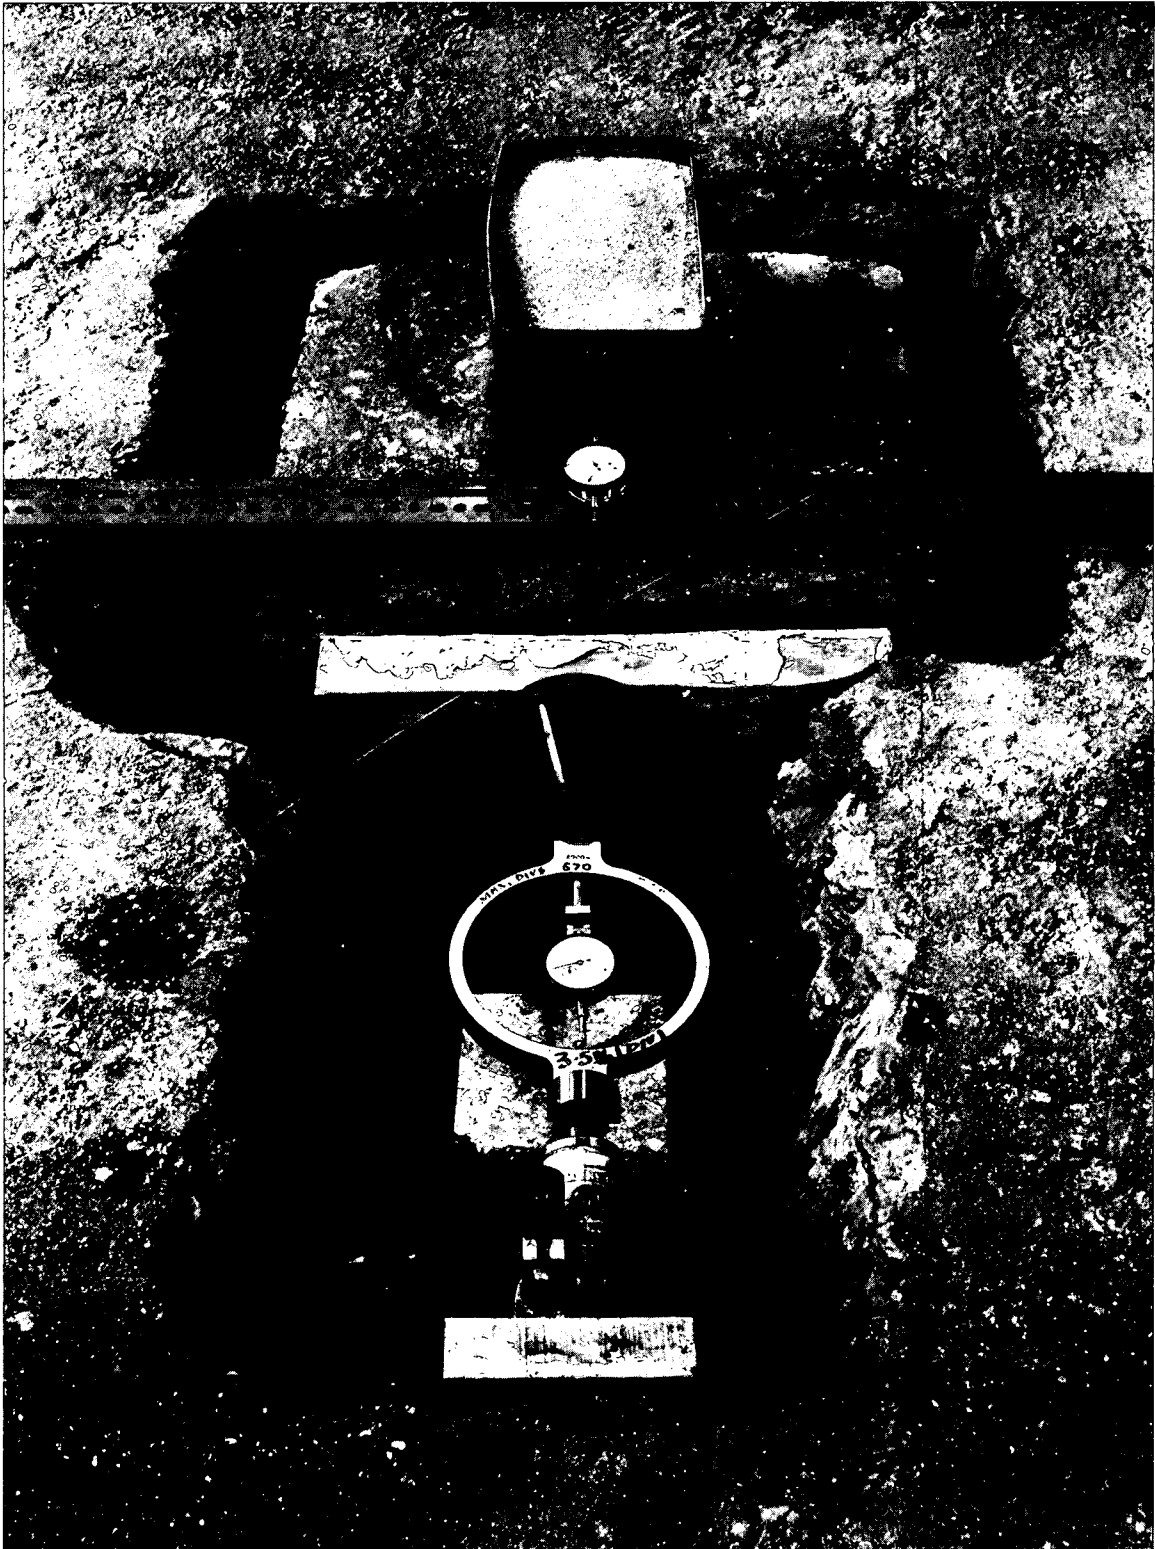
PLATE 5 Subgrade restraint test

Subgrade-restraint tests were performed on square blocks approximately 45 cm x 45 cm (18 in x 18 in) from which the surrounding base material had been removed. A jack applied a horizontal load to the block through a proving ring and the horizontal movement of the block was measured by a dial gauge. A photograph of a subgrade restraint test is shown in Plate 5.
