TITLE Highway slope problems in Indonesia

by **W Heath, B S Saroso and J W F Dowling**

Heath, W G, B S Saroso and J W F Dowling, 1990. Highway slope problems in Indonesia. In: REAAA. Proceedings of the 6th Conference of REAAA. Kuala Lumpur 4 - 10 march 1990.

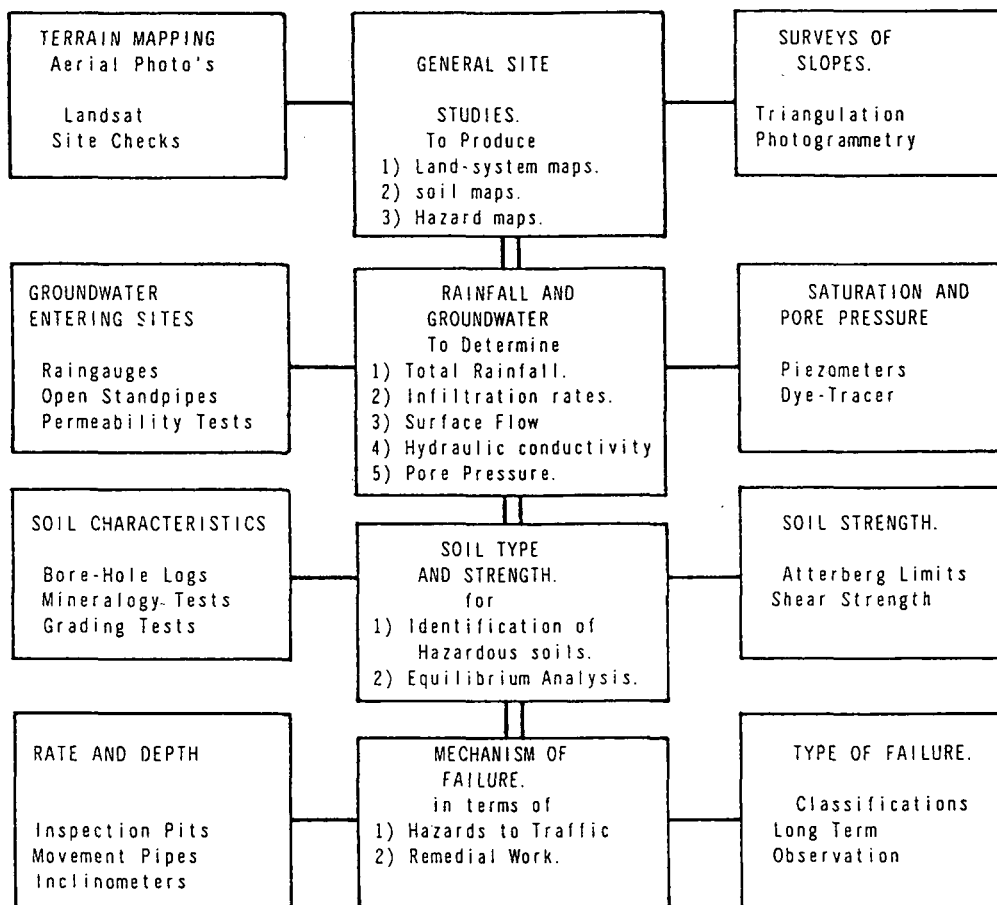
FIGURE 2. Main tasks of the landslide study.

15. The study of the selected sites including four main investigation phases; a desk study, instrumenting slopes to determine groundwater, collecting and testing soil samples and determining the depth and rate of failure, see Figure 2
