Technical Committee C12: Subject 12.2

THE METHODOLOGY AND RESULTS OF SLOPE STABILITY STUDIES IN INDONESIA

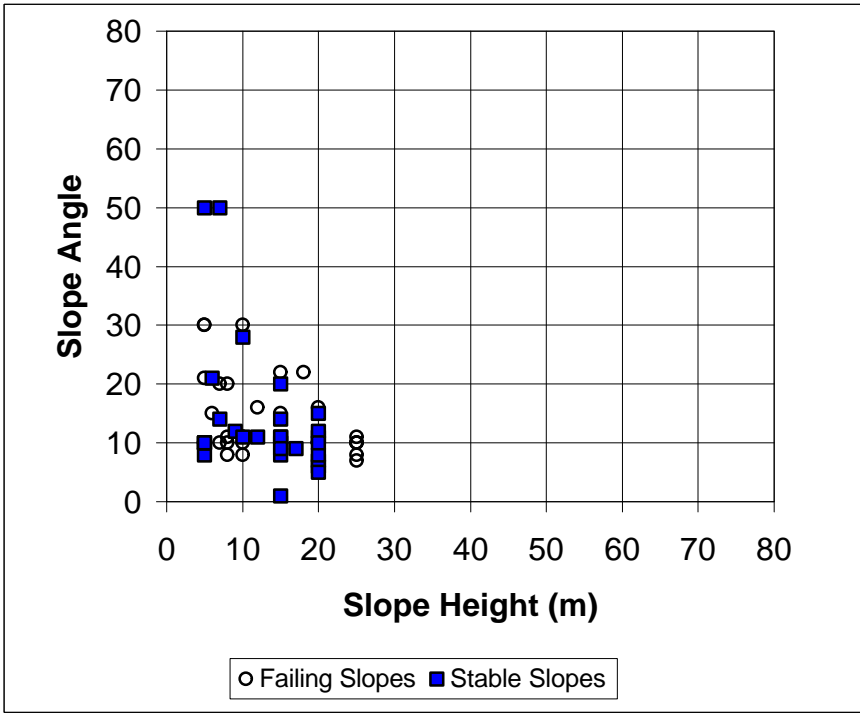
Figure 3 Slope Height-Angle Relationships for Volcanic Cut-Slopes in a Single Land System

1. In the Recent volcanic tropically weathered residual soils, slopes up to 12m maximum height can be safely cut at about 60° (3V:1H), see Figure 3. Failure hazard can be further reduced by regularly maintained drainage and erosion protection enabling even steeper slope angles to be cut in some circumstances.
