ACCESS TO SMALL VEHICLES IN DEVELOPING COUNTRIES

**Thomas Rickert, Executive Director
Access Exchange International, USA**

ACCESS TO MEXICO CITY’S MICROS AND REPLACEMENT VEHICLES

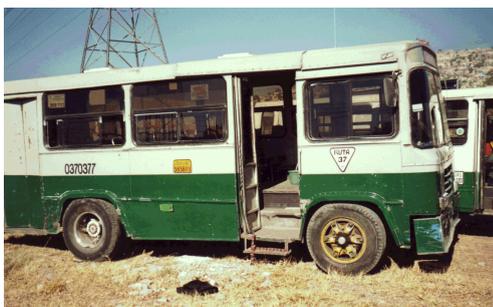
Public transport in Mexico City includes municipally managed Metro, large bus, and electric (LRV, trolley) modes, in addition to micros such as the vehicle shown in the photo at left. The Federal District’s Transportation Law requires SETRAVI to promote accessible public transport services (Ley de Transporte, 1999).

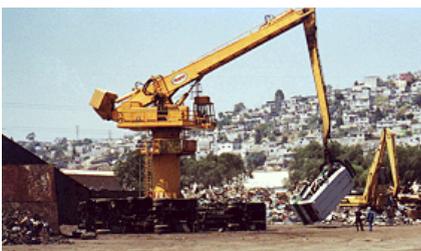
replacement program also provides an opportunity to consider universal design features for the micro fleet, which in turn could benefit passengers with disabilities. Currently, Federal District authorities are buying and destroying old micros built prior to 1991 for 100,000 pesos or about US\$11,000, which goes toward the purchase of somewhat larger buses by the previous owners. (See photo of recycling of old micros, at left.)

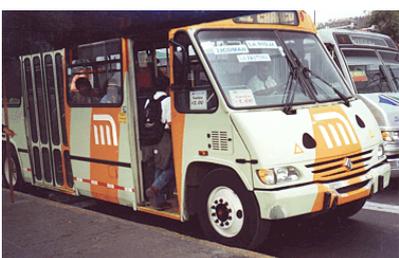
The table below compares the features of old micros with new model replacement vehicles, such as pictured at left. The table notes improved access features while also recommending additional features based on concerns raised by disability advocates in Mexico City. Advocates especially focused on the need for lower first steps, wider doors, additional hand grasps, and improved audio and

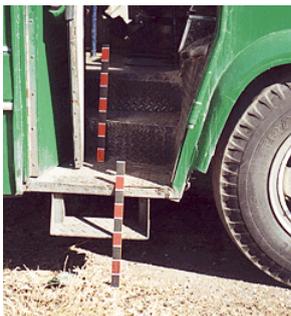
bumps would damage an added lower step beneath the front entrance, the driver-owners of two old micros (out of fifty) at a recycling facility had soldered on an extra step in order “to help older people get on.” (See photo at left, noting each mark on the ruler equals 5 cm.) They had not experienced damage to the inexpensive additional step, located immediately behind the front tire. This extra step halves the distance to the first step inside the vehicle, so that a passenger need only climb four 20 cm. steps. Alternatives to this approach include a retractable lower step mechanically operated by the driver, provision of a kneeler device (depending on vehicle design), and modification of curb heights at stops where vehicles can be effectively channeled adjacent to the stop either by physical barriers or through driver training.

- Reduction of the distance up to the first step is another critical area for exploration. Work is needed on the use of different approaches to reduce the ground-to-first-step distance from 40 cm. to no more than 25 cm. under infrastructure conditions found in Latin American cities. While it was the opinion of SETRAVI officials that speed
